STATE OF MARYLAND
BOARD OF NATURAL RESOURCES
DEPARTMENT OF GEOLOGY, MINES AND WATER RESOURCES
JOSEPH T. SINGEWALD, JR., *Director*

BULLETIN 6
SHORE EROSION
IN
TIDEWATER MARYLAND

1949

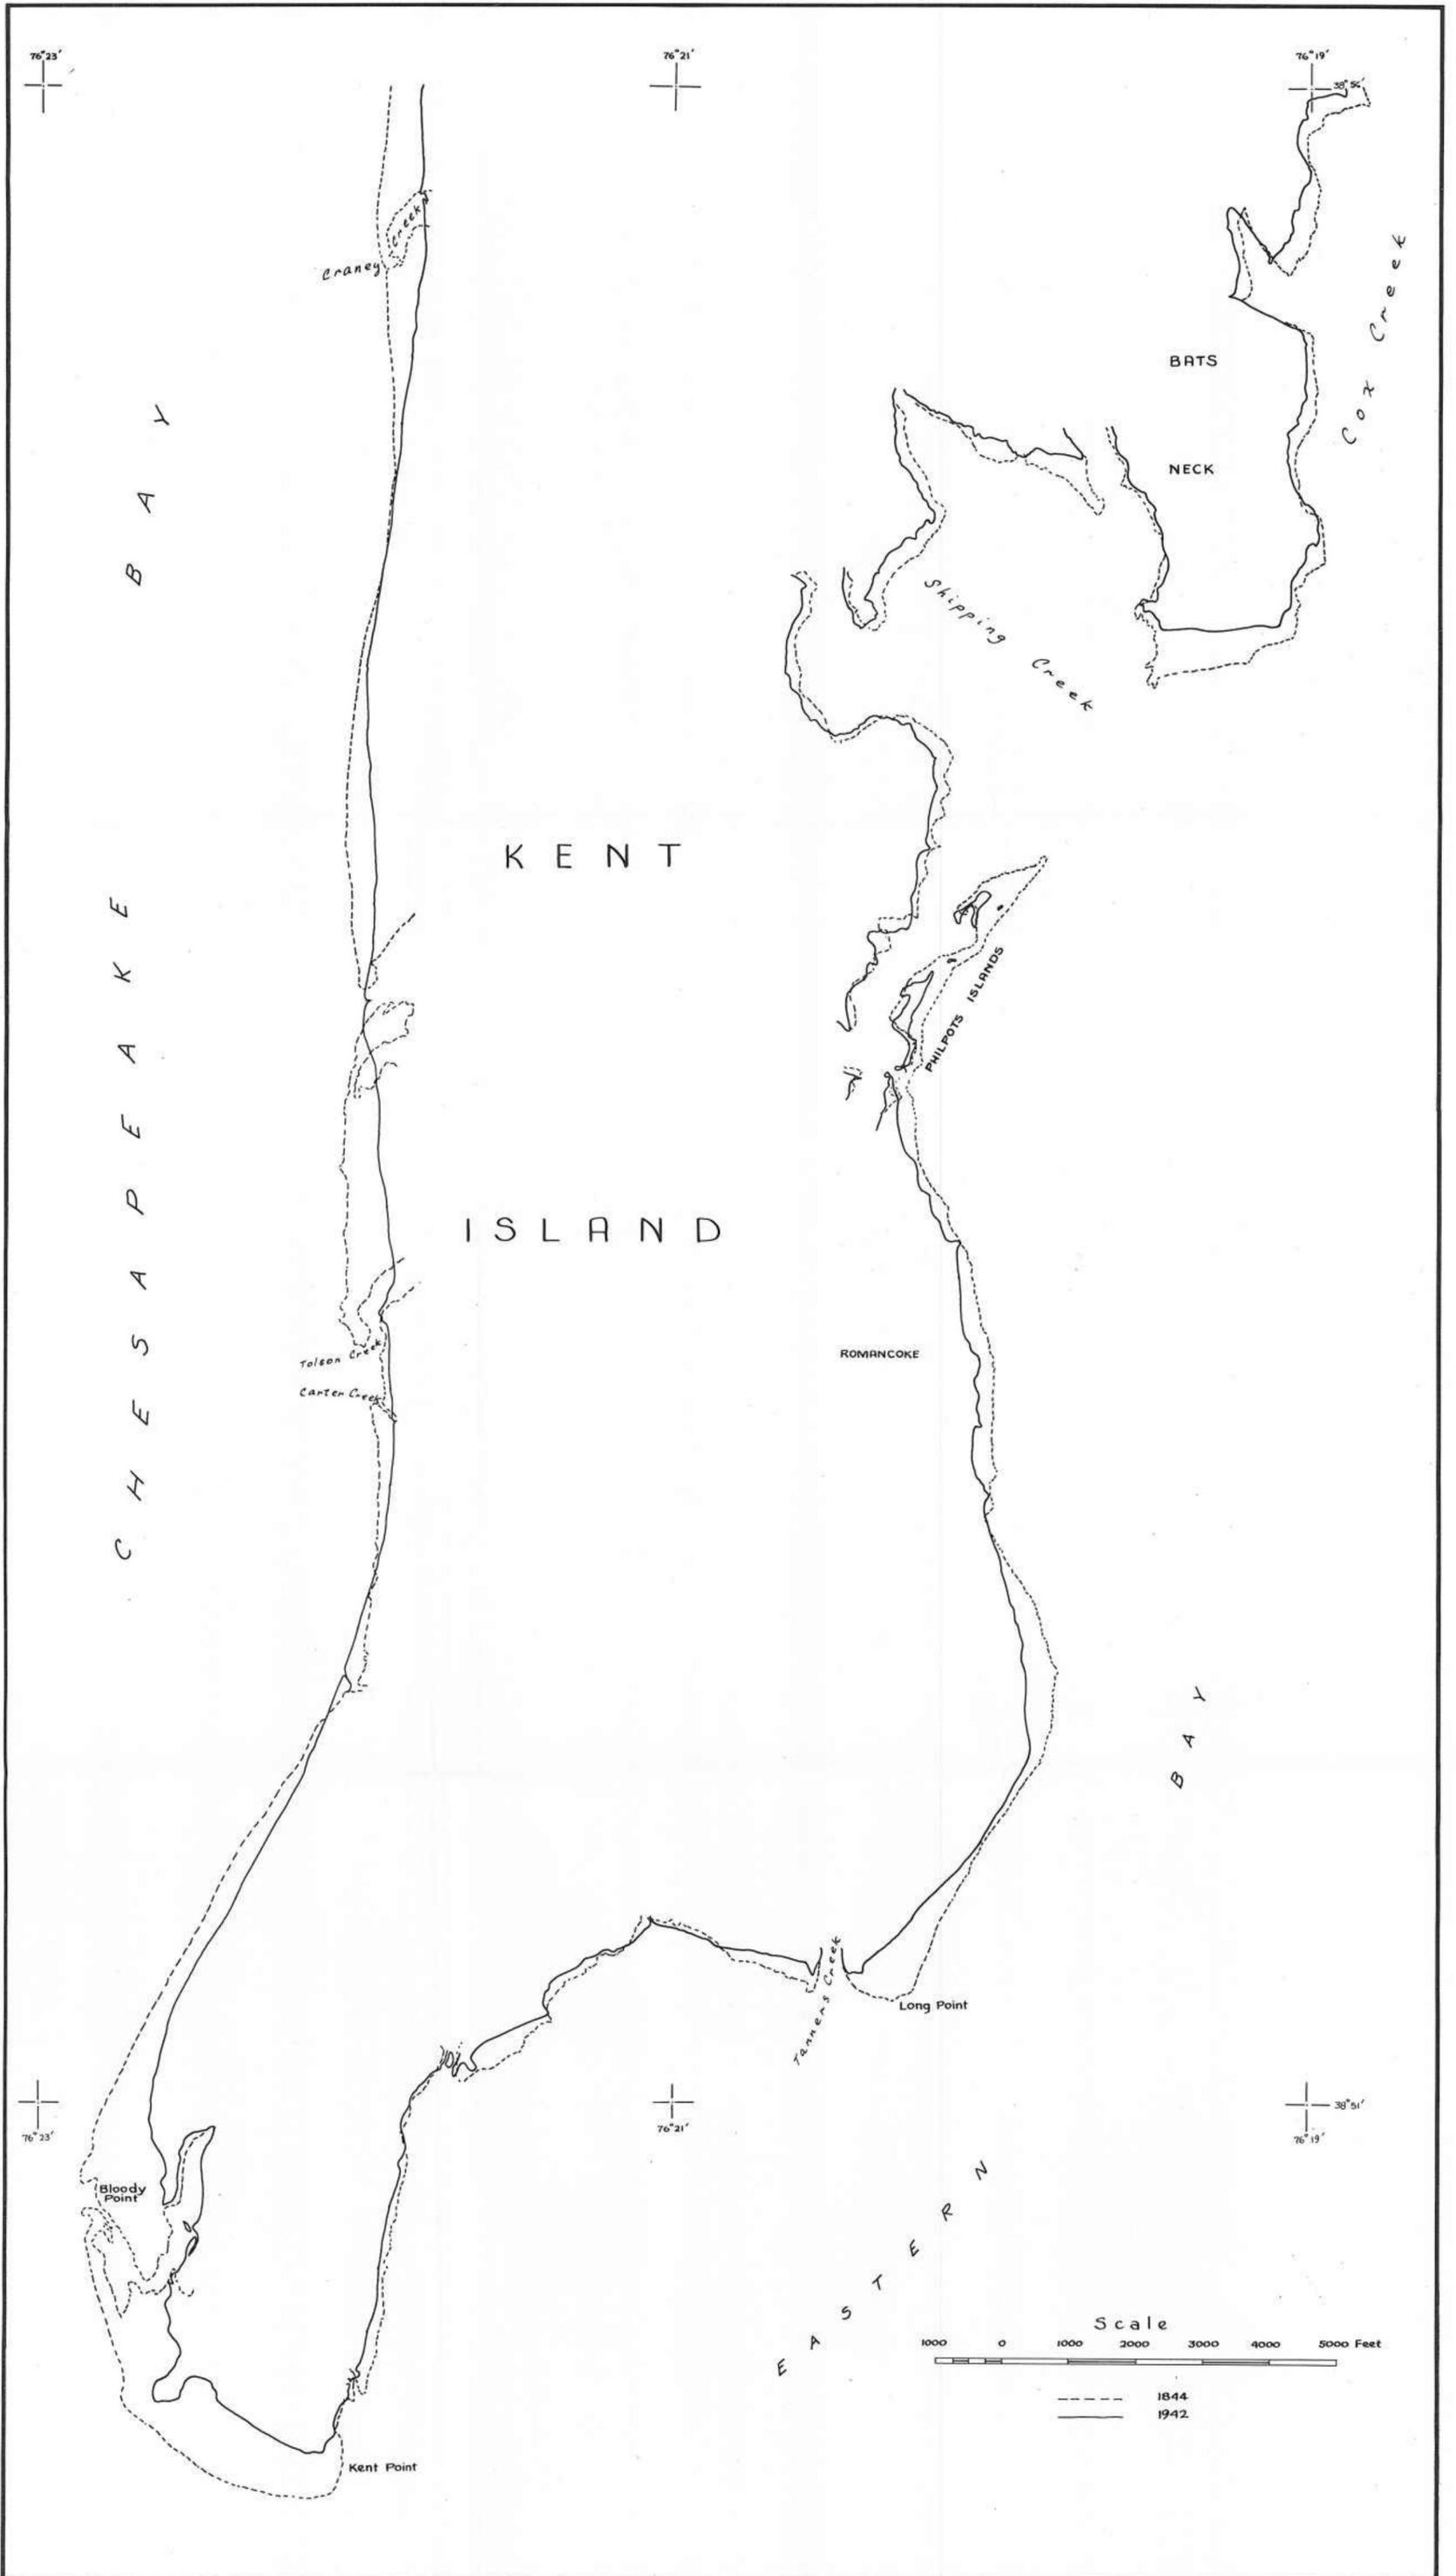
PLATE 18. Shore Line Changes from Craney Creek to Kent Point and from Kent Point to Cox Creek, Queen Annes County

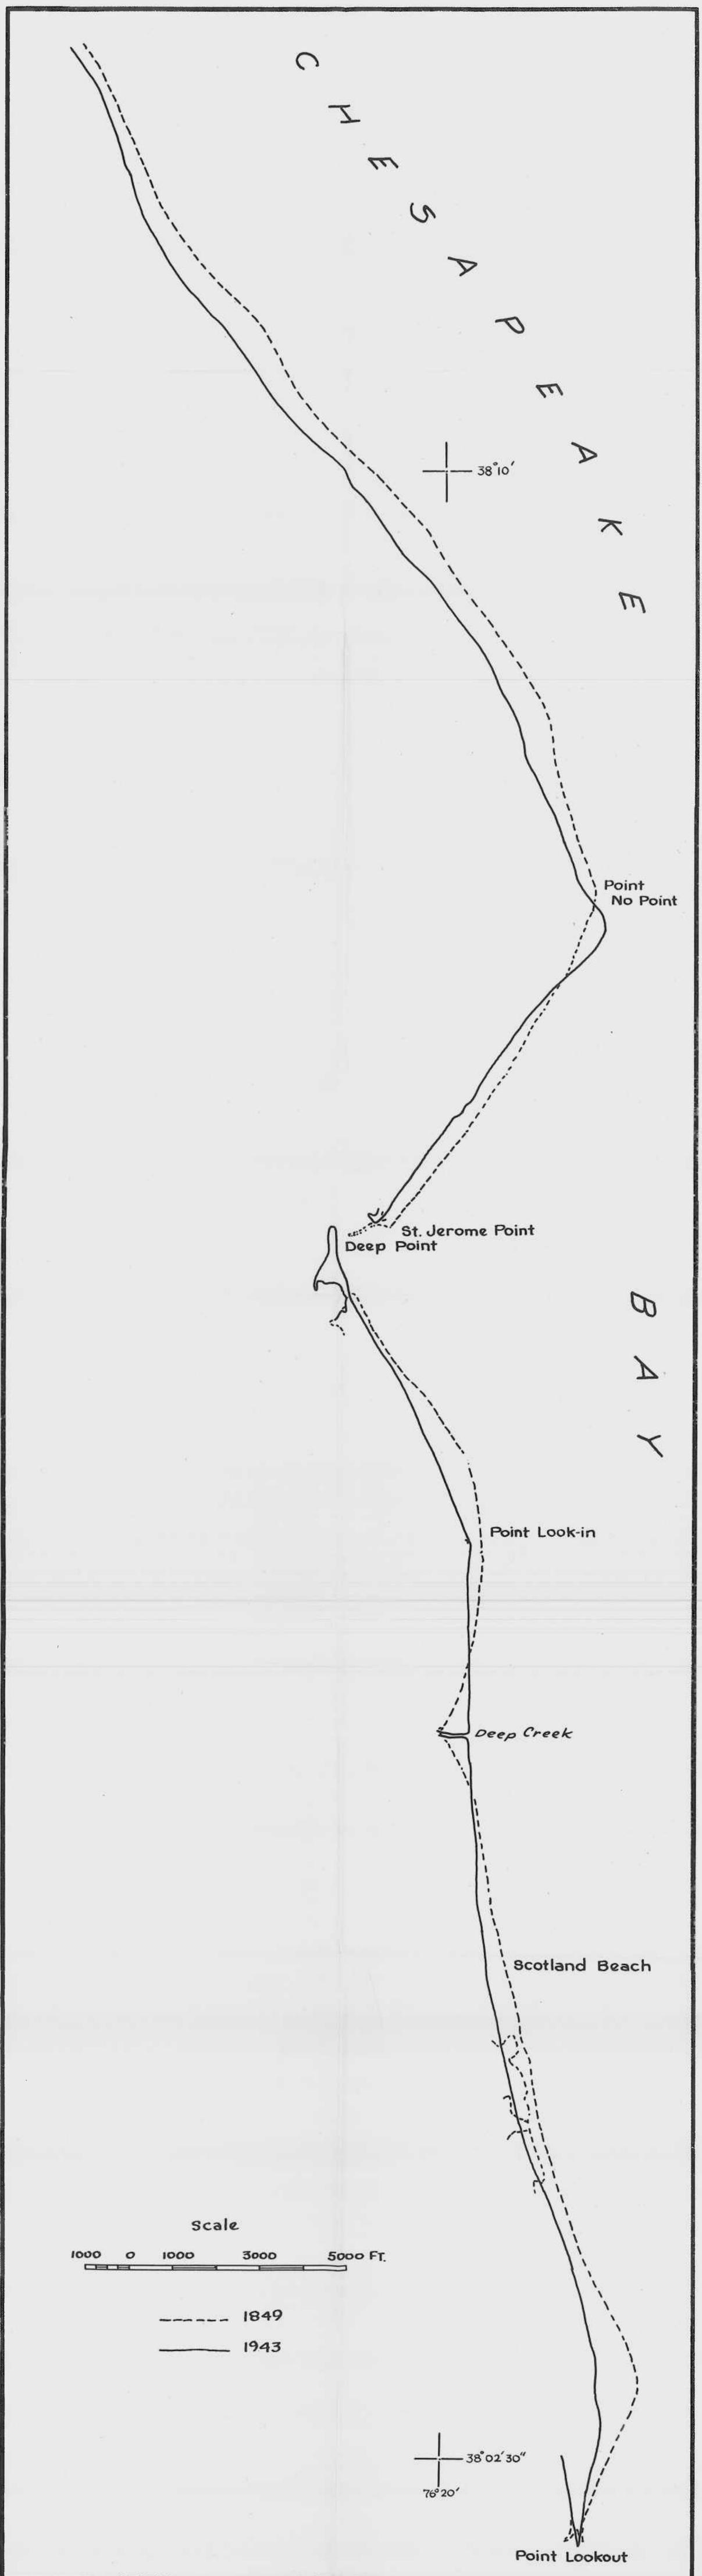
PLATE 19. Shore Line Changes from 4 1/2 Miles Northwest of Point No Point to Point Lookout, St. Marys County

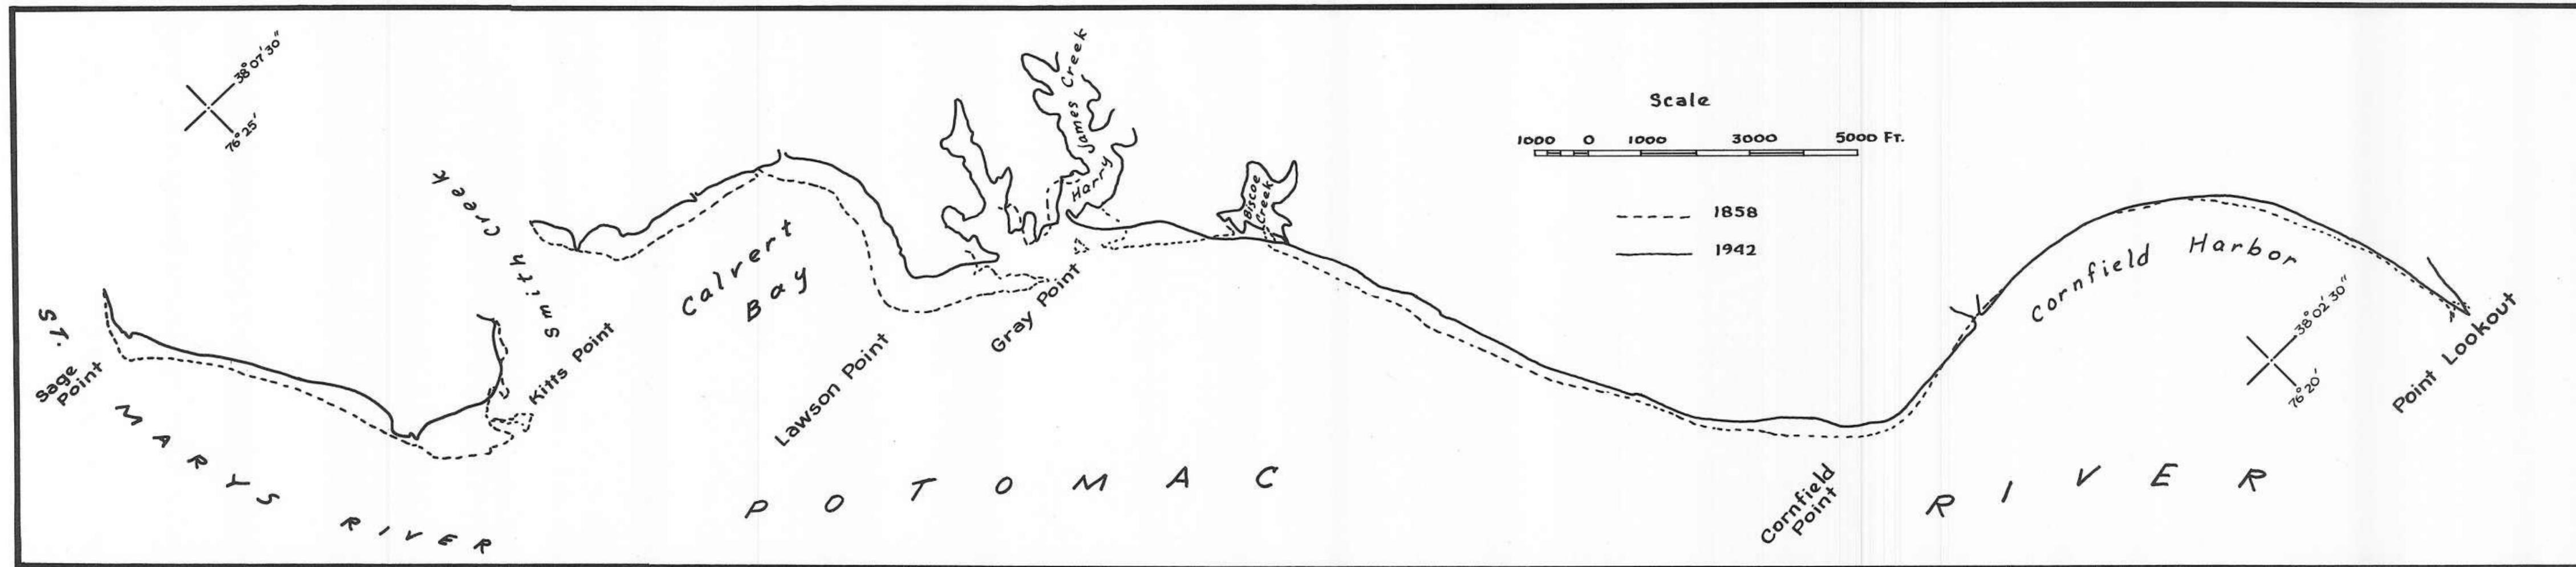
PLATE 20. Shore Line Changes from Sage Point to Point Lookout, St. Marys County

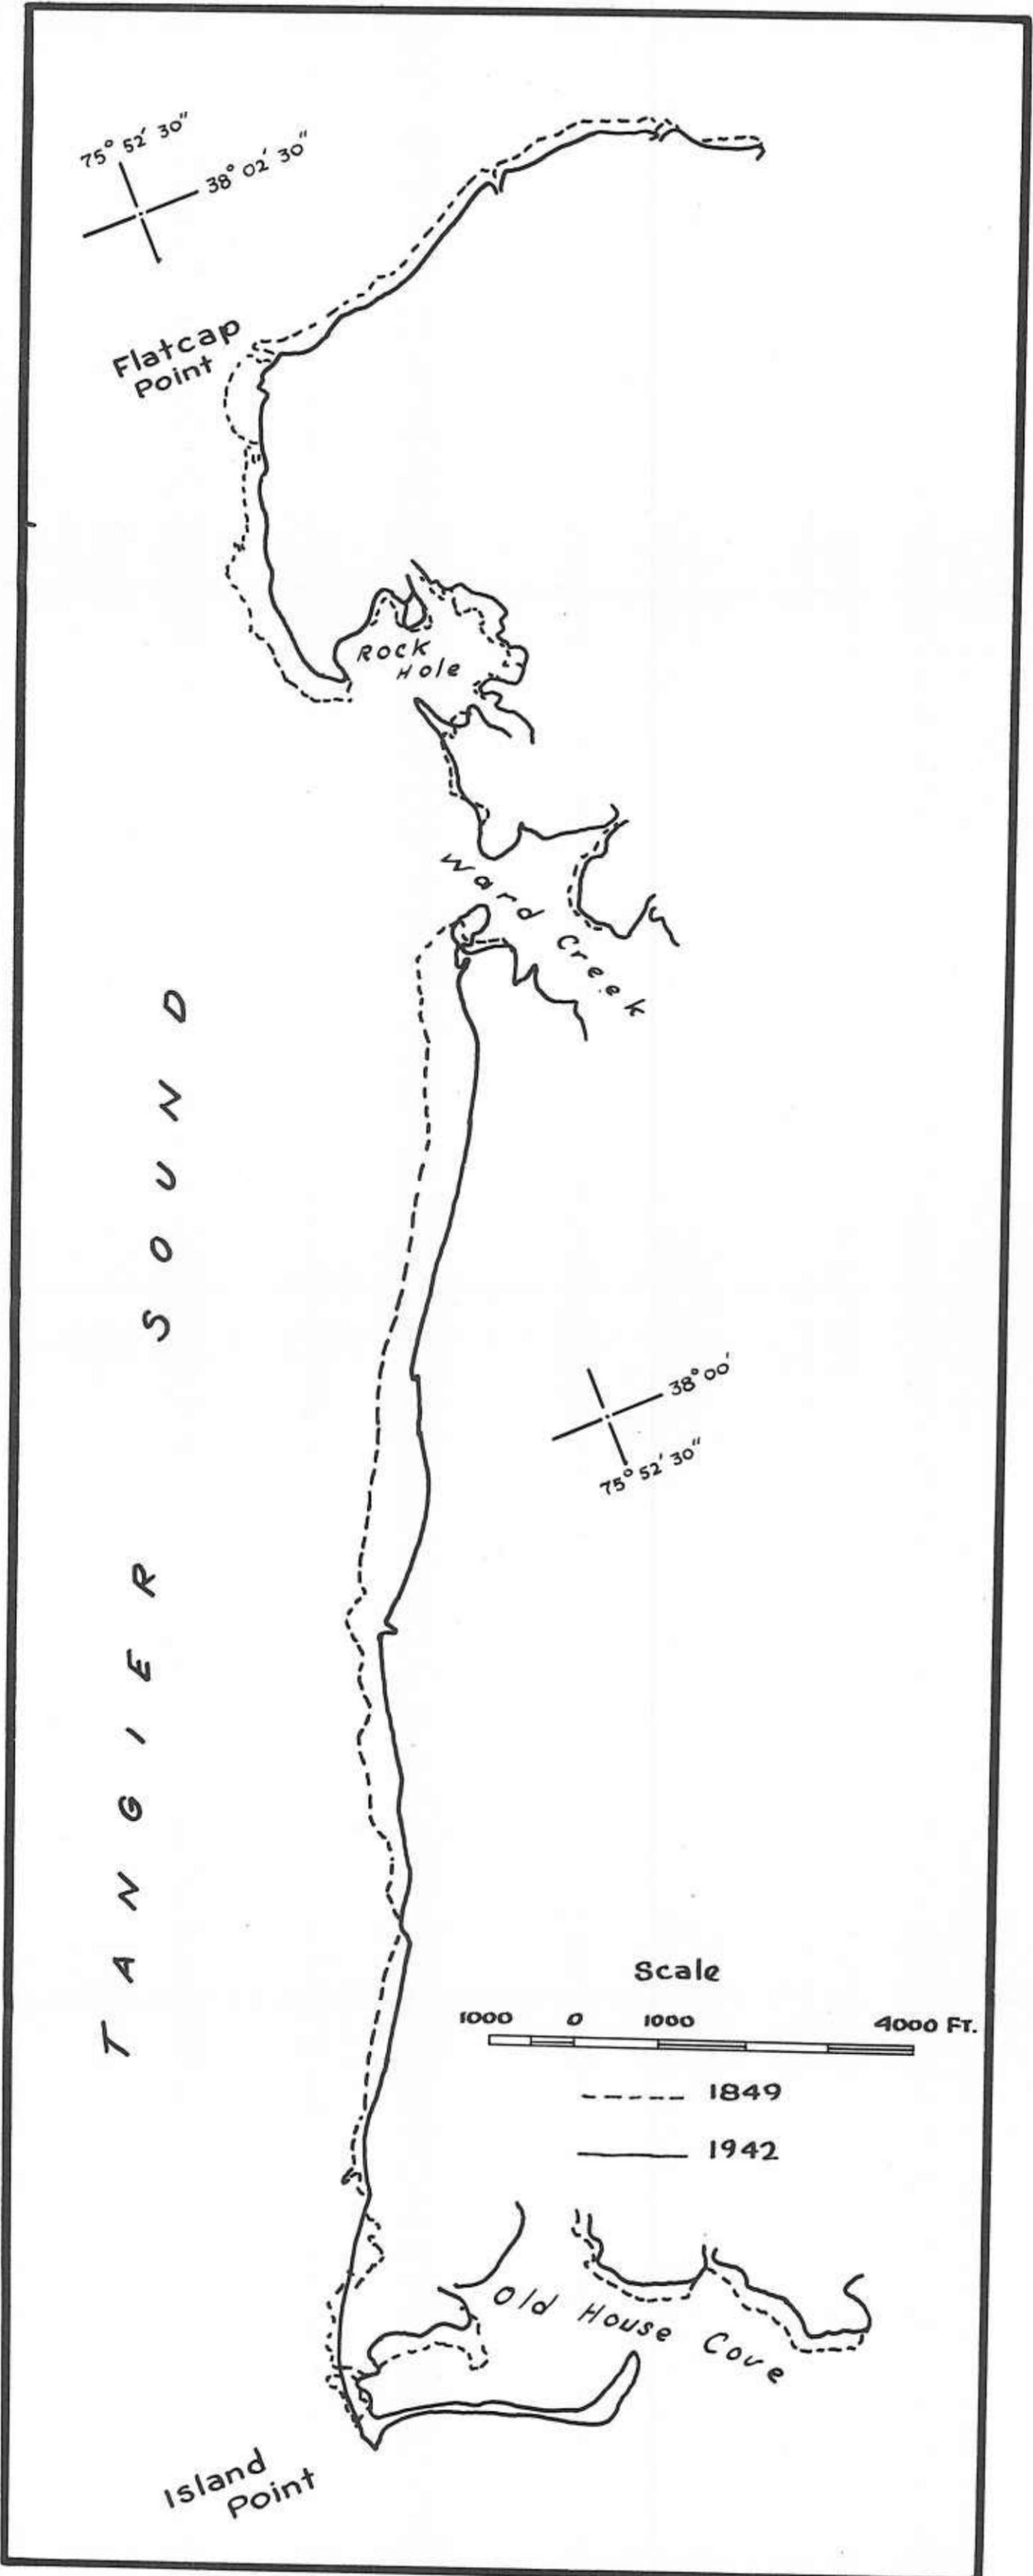
PLATE 21. Shore Line Changes from Flatcap Point to Old House Cove, Tangier Sound, Somerset County

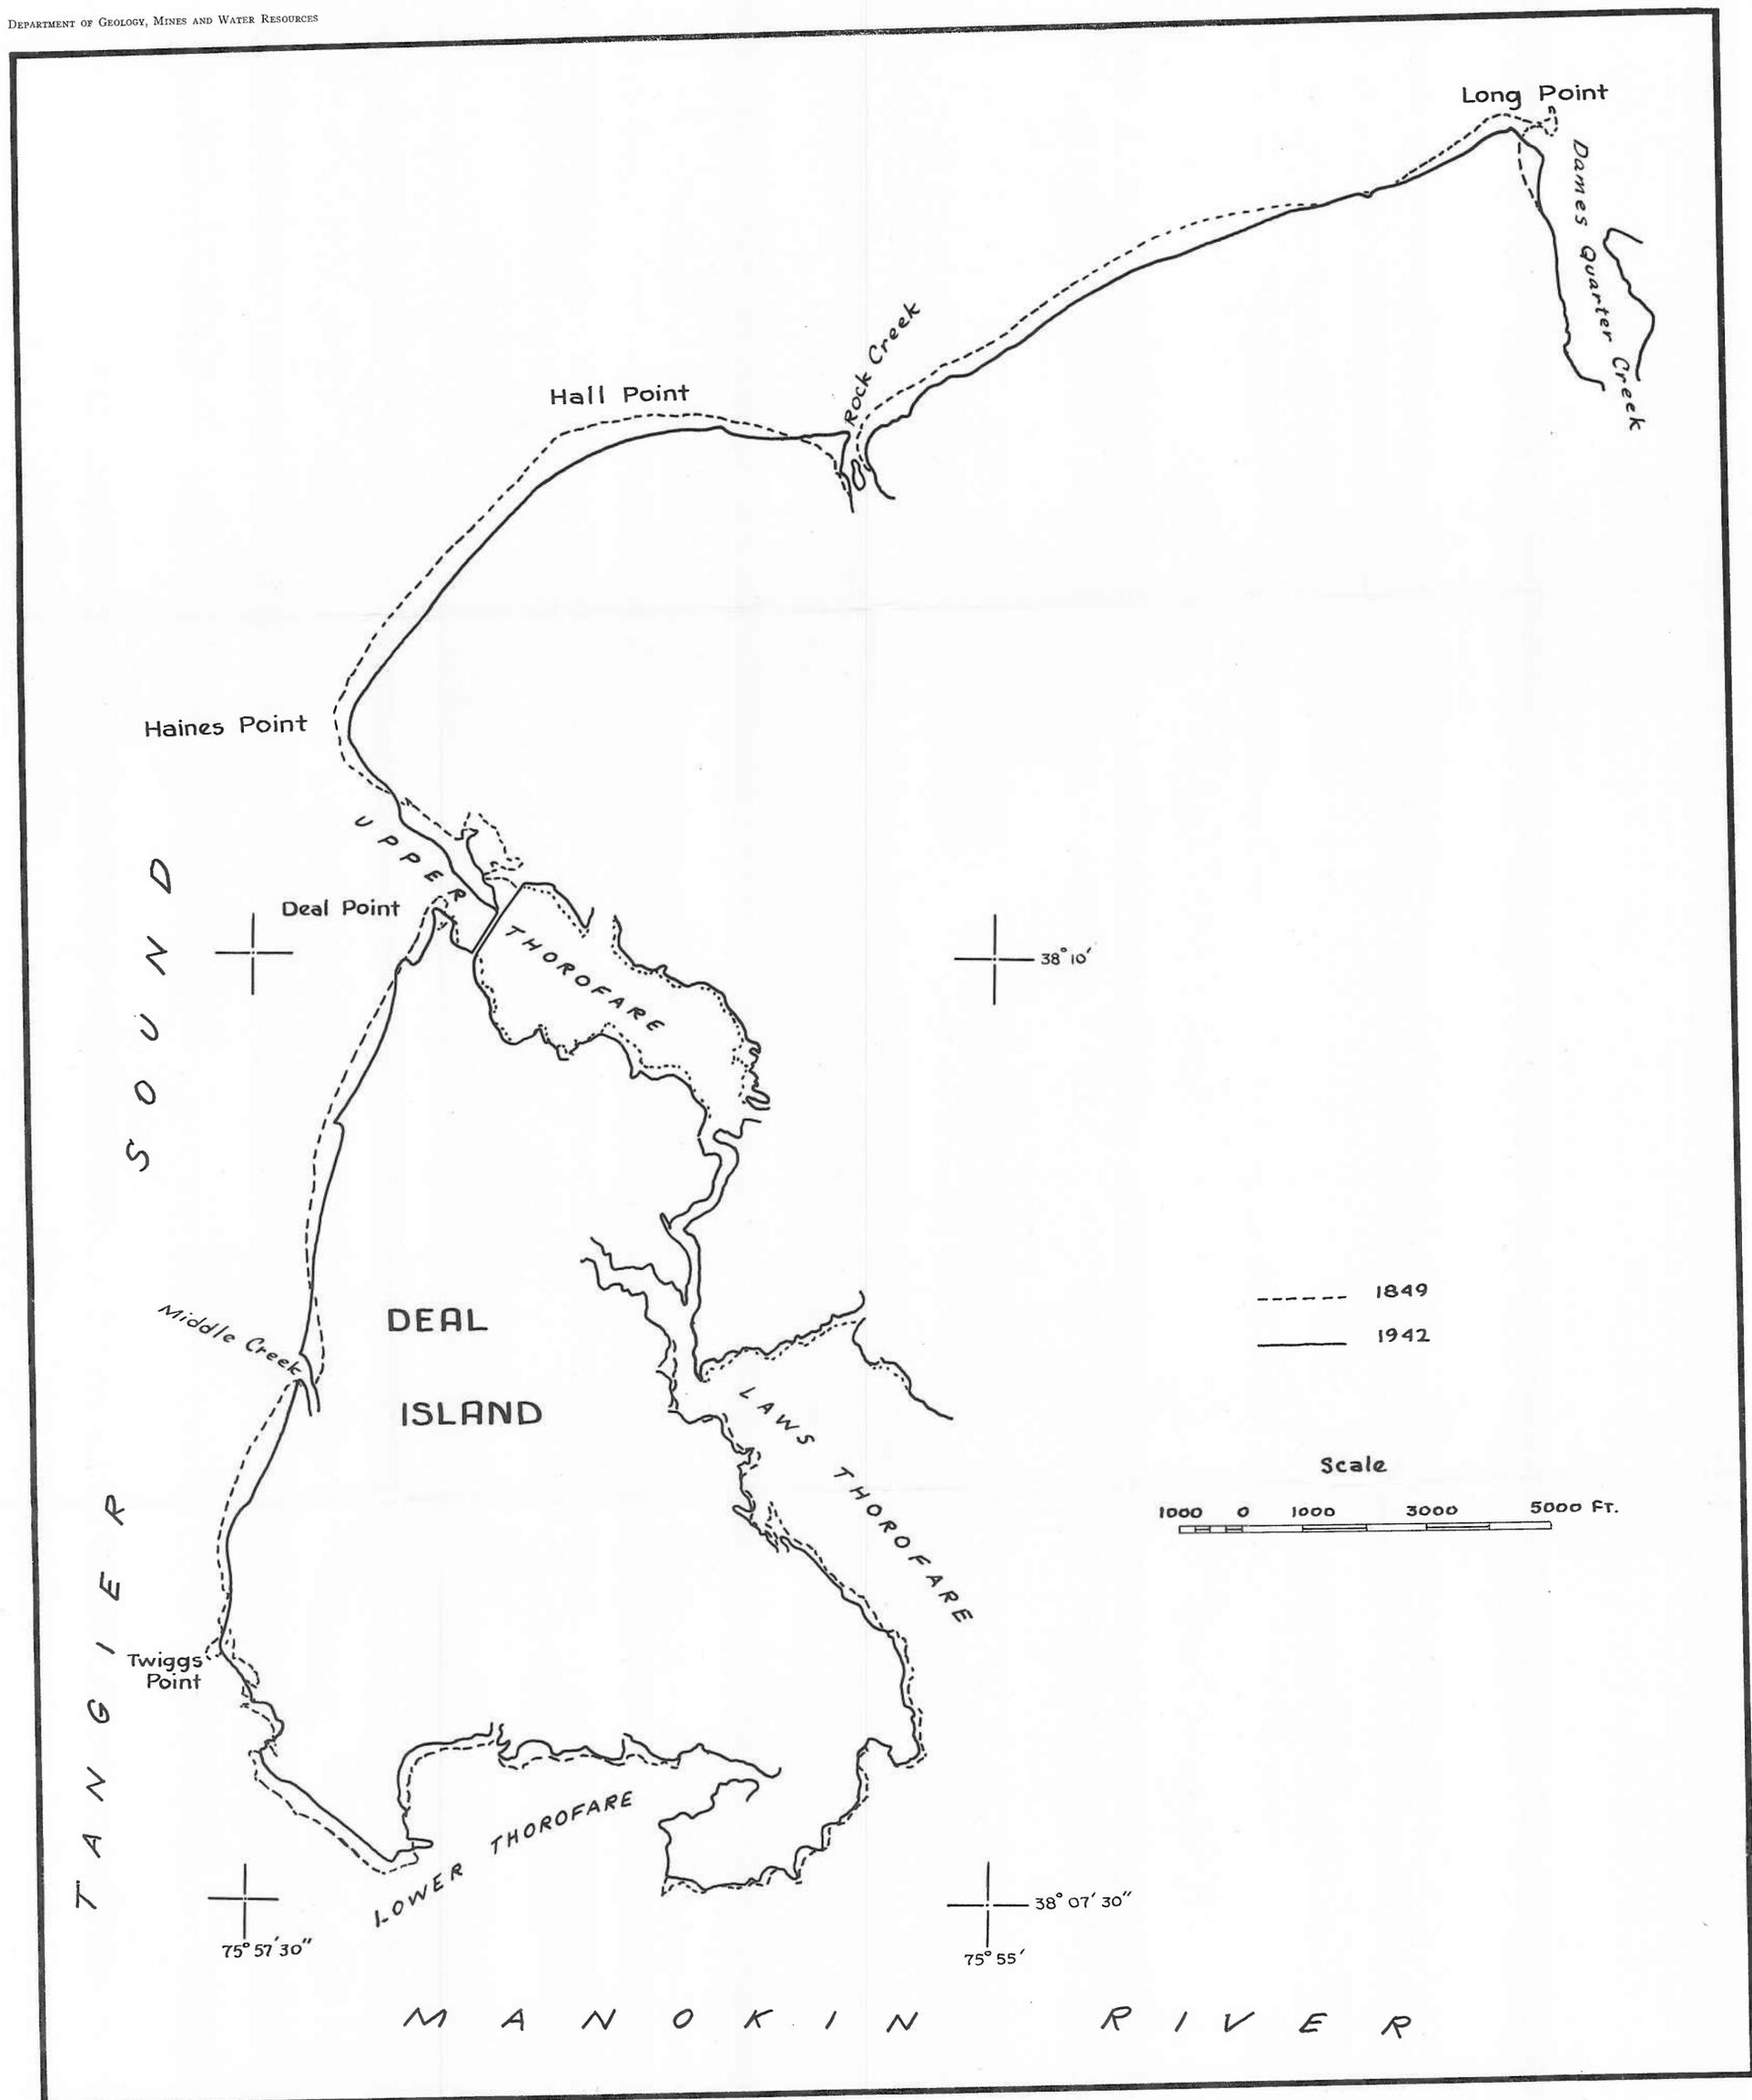
PLATE 22. Shore Line Changes from Long Point to Lower Thorofare, Tangier Sound, Somerset County

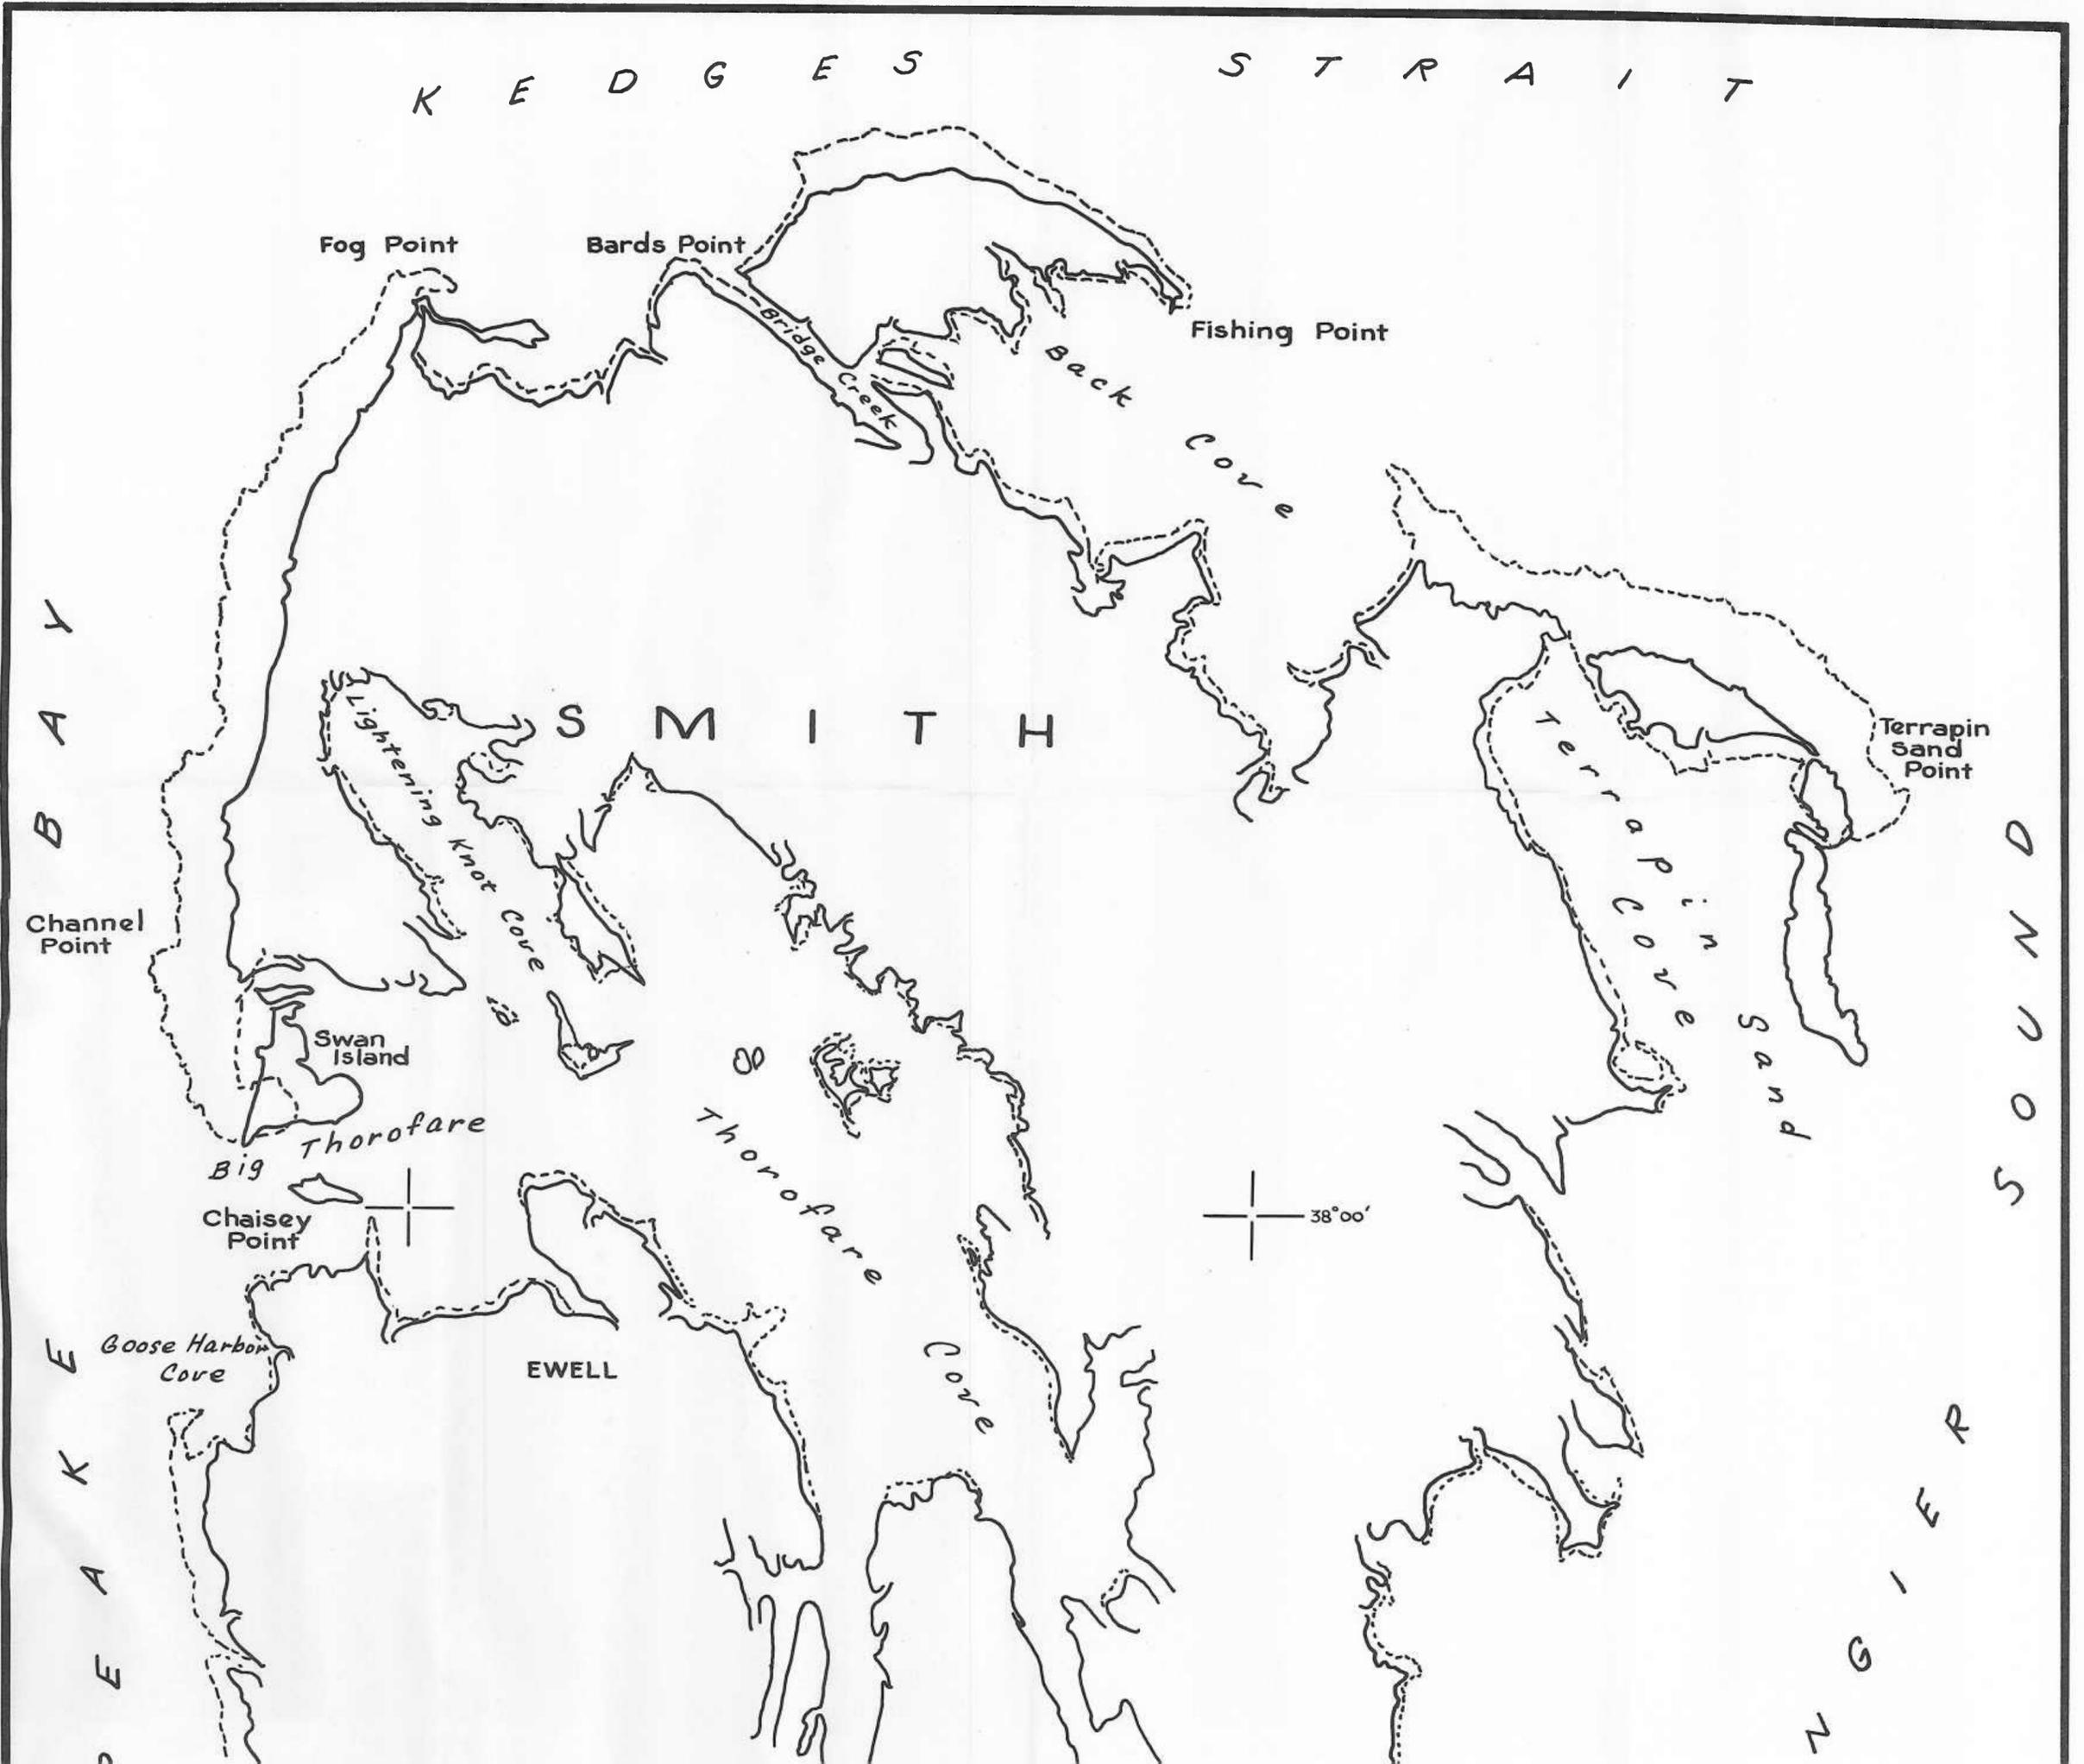
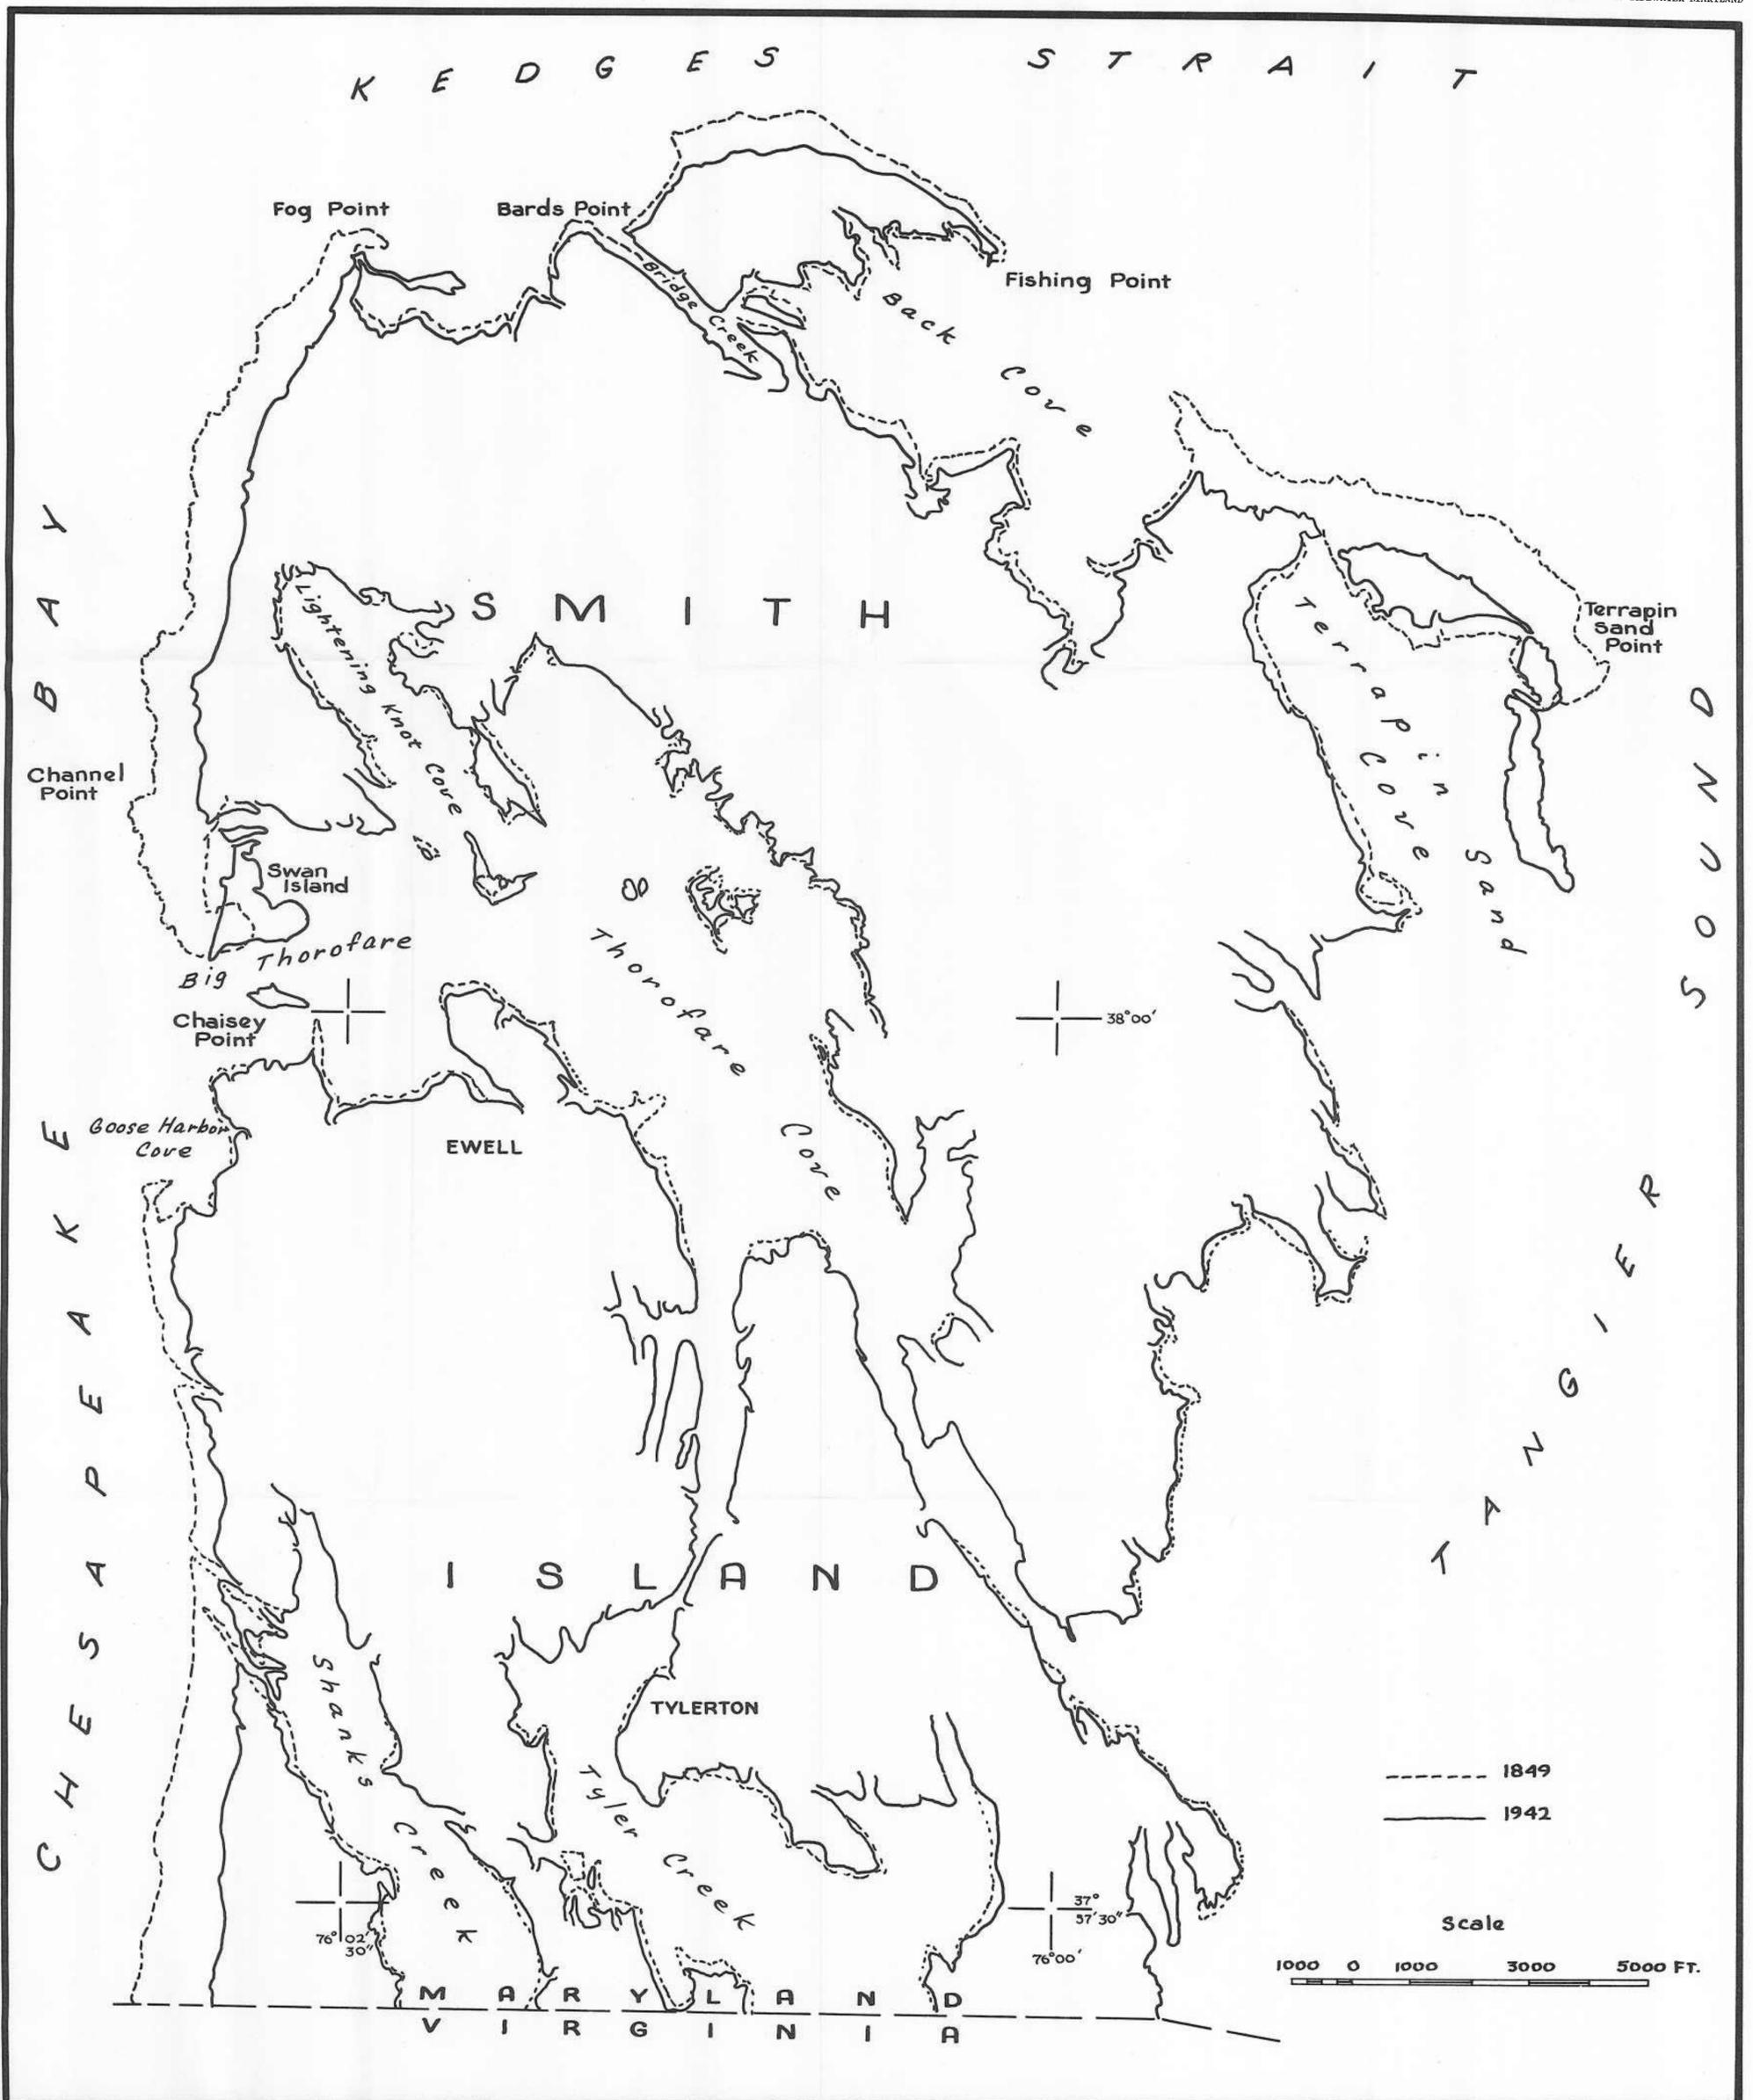
PLATE 23. Shore Line Changes on Smith Island, Somerset County
